U.S. ENVIRONMENTAL PROTECTION AGENCY POLLUTION/SITUATION REPORT 2015 Gold King Mine Release SITREP

Subject: SITREP #5

Gold King Mine Release

San Juan County, Colorado

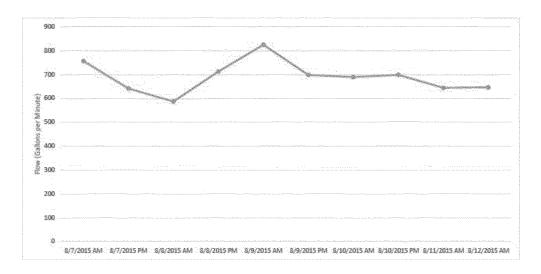
The EPA continues to operate four treatment and sedimentation ponds at the mine site which are treating water by lowering acidity levels and removing dissolved metals. Flow from the mine through the morning of 8/12/2015 is shown in the following chart. As of 11 am on 8/13/2015, there was no available updated water discharge data available.

Treated water from the last treatment pond is discharging into Cement Creek at levels cleaner (higher pH and lower levels of metals) than pre-event, background conditions in the creek. Flow data out of the mine is being collected manually two times per day. Water quality data is being collected at the influent and effluent of the treatment system as well.
